BIOLOGICAL TREATMENT OF  
IRRIGATION PONDS FOR ALGAE CONTROL

**MicroCat-AL-N+**

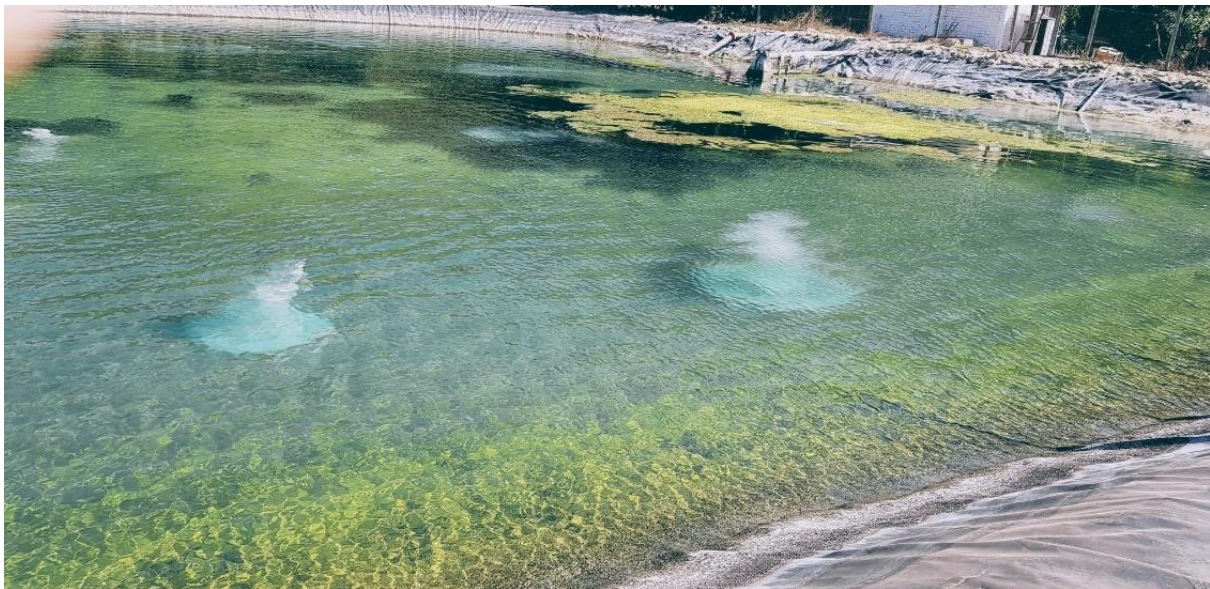
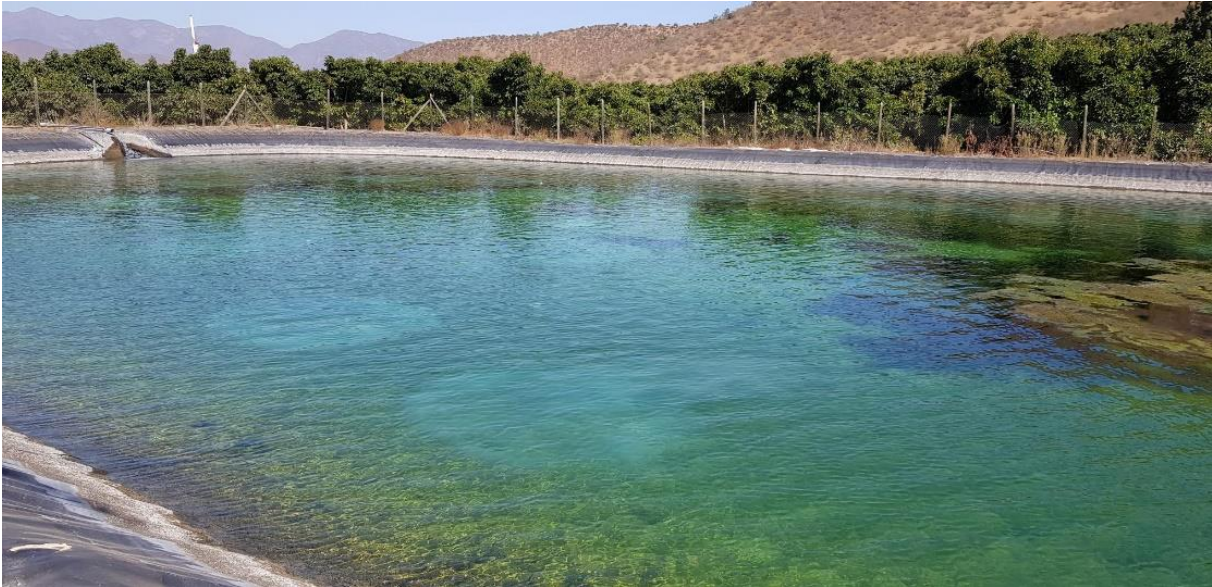
The product is applied manually using water-soluble bags, typically 250 grams each, ensuring uniform distribution throughout the pond.

This application method allows for quick and efficient treatment without requiring additional equipment while ensuring complete coverage.

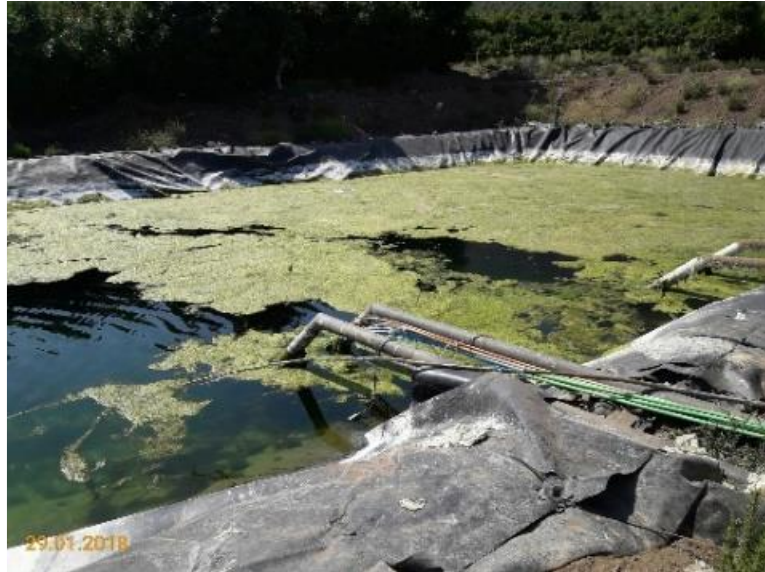
During the peak irrigation season, the pond was left untreated, leading to excessive algae growth that clogged filters and drippers.

Due to low water retention, and after removing floating algae, a high dose of 3.75 kg of **MicroCat-AL-N+** was applied twice weekly, equivalent to 0.82 g/m<sup>3</sup> of irrigated water.

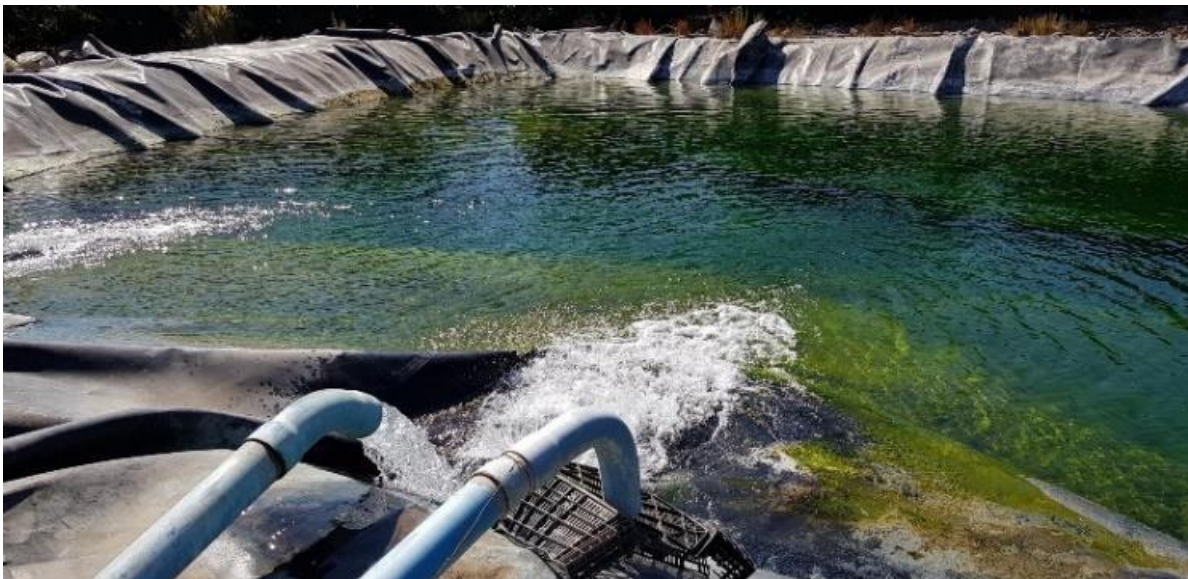
After cleaning and applying the recommended doses, the pond remained in perfect condition, resolving the severe clogging issue.

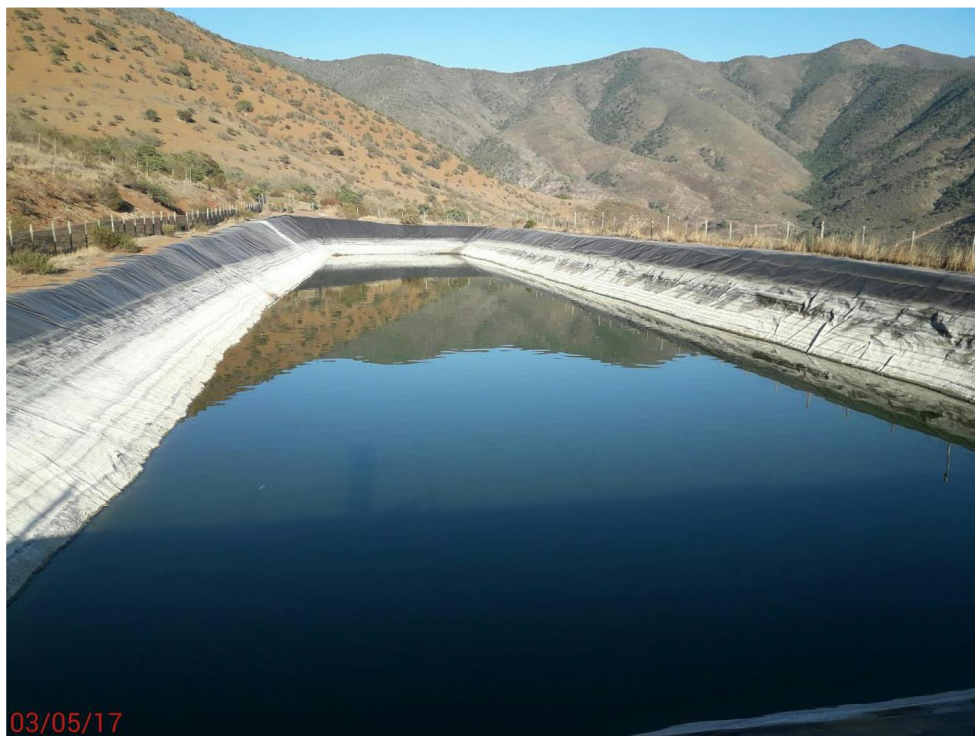
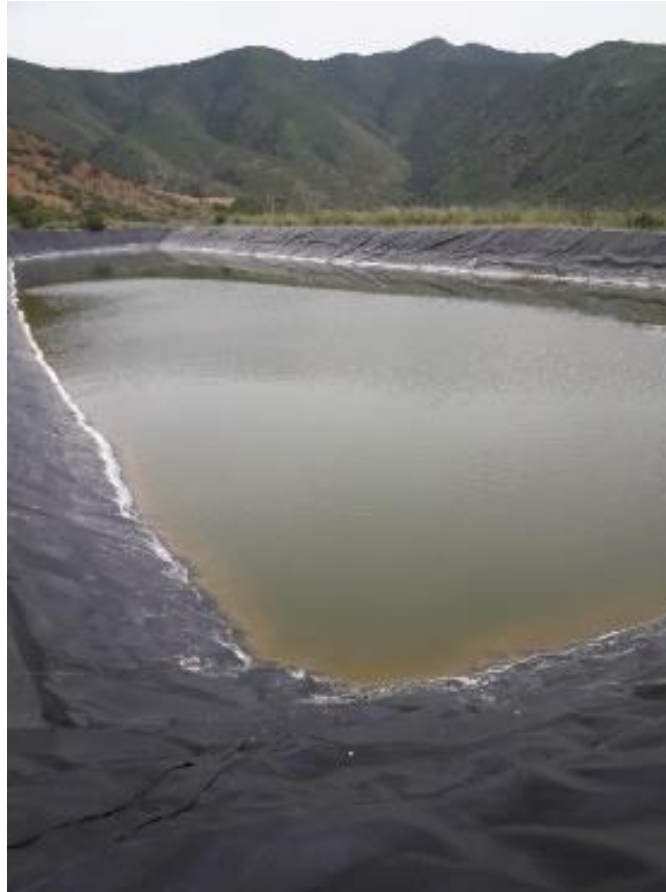
The pond remained clean throughout the irrigation period, with no algae accumulation.

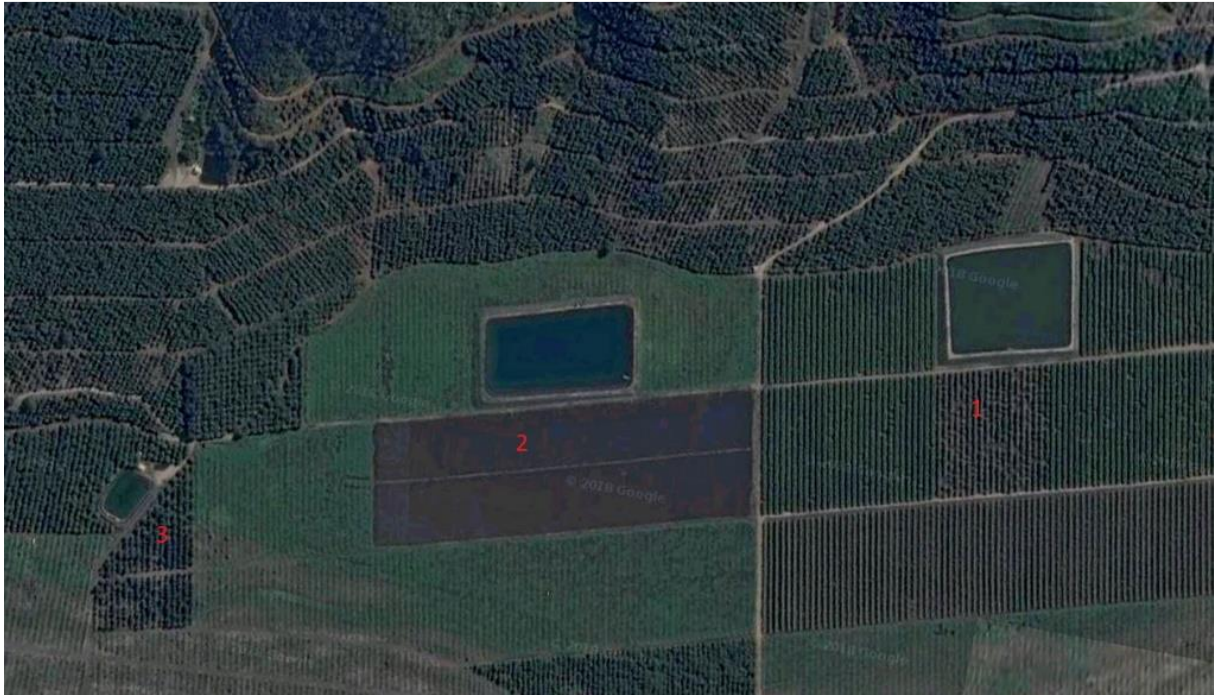
Water from Pond N°1 is transferred entirely to Pond N°2 , which then pumps all its water to Pond N°3, which also receives direct input from various wells.

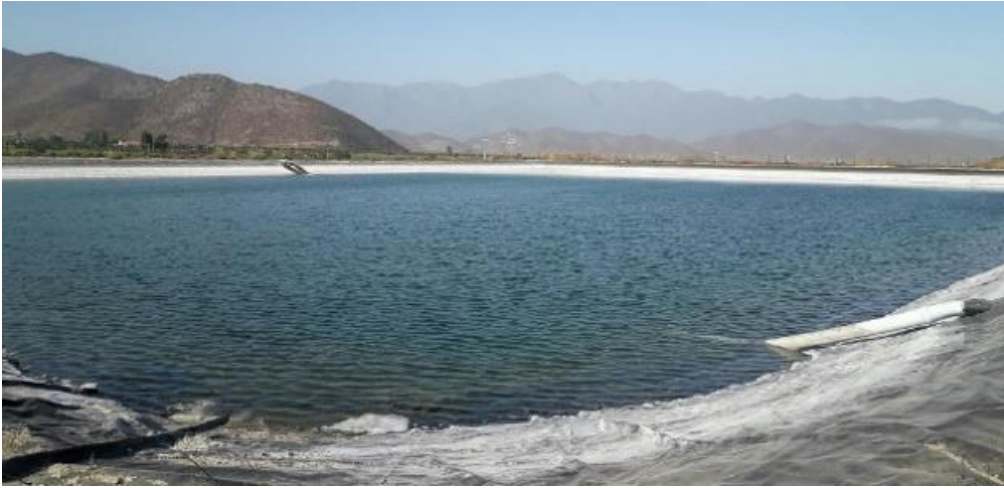
Pond 1

By the end of the irrigation season, the ponds remained in optimal condition, preventing clogging issues.

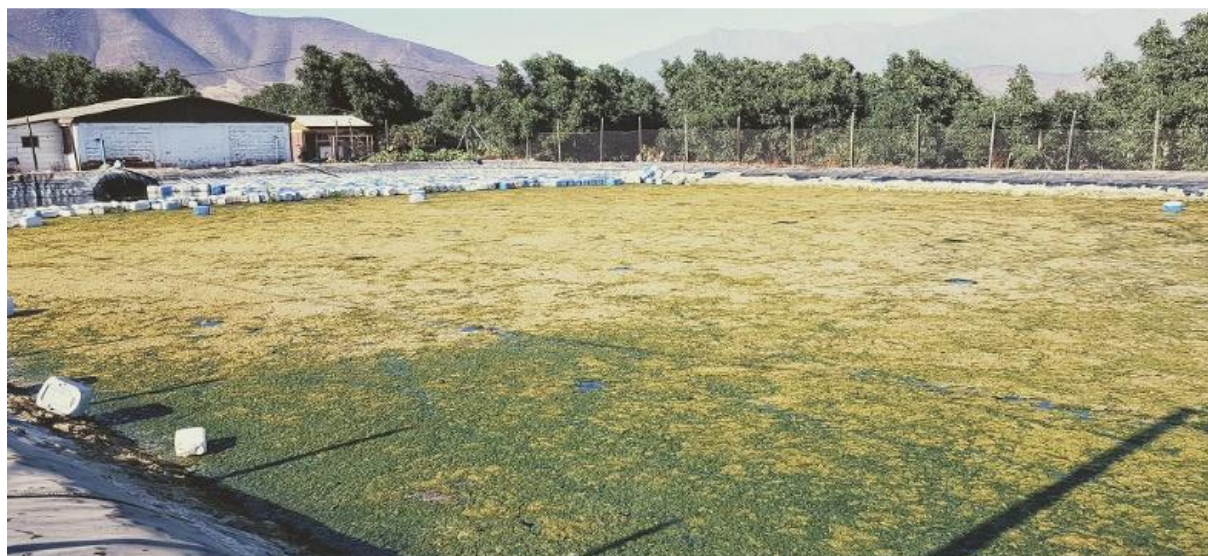
Surface Area (m <sup>2</sup> )	Volume (m <sup>3</sup> )	Water Source	Irrigated Volume (m <sup>3</sup> /month)	Retention (days)	Lining
3,000	10,000	Well	73,000	4.1	Geomembrane

This pond is filled with well water and irrigates 50 hectares with 425,000 m<sup>3</sup> of water, of which 219,000 m<sup>3</sup> are used between January and March.

Biological treatment began at the start of the season, meaning there was no time for cleaning, and the pond was received completely covered in algae. The goal of the treatment was not to eliminate existing algae, but rather to prevent further deterioration and minimize clogging of drippers and filters.

The pond remained in the same condition throughout the season, without an increase in algae growth.

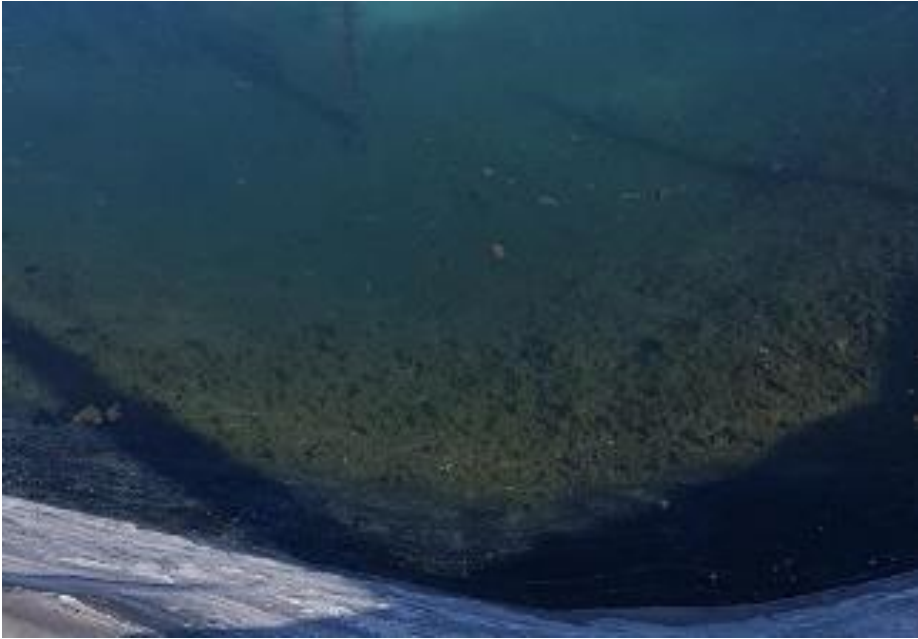
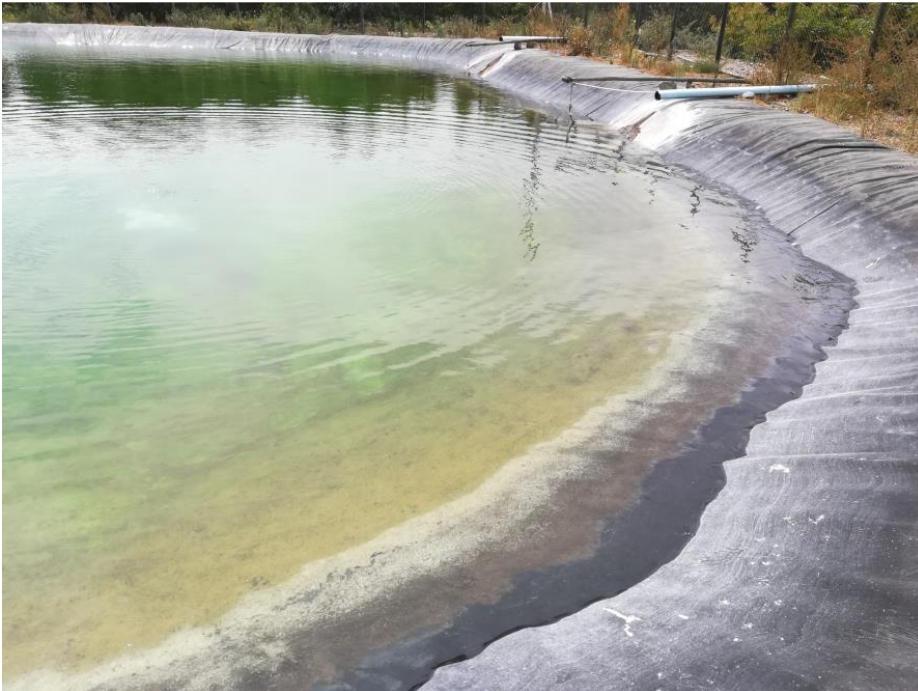
With the specified dosage, the water remained almost completely free of microalgae, significantly reducing clogging issues, which was evident in the improved water clarity.

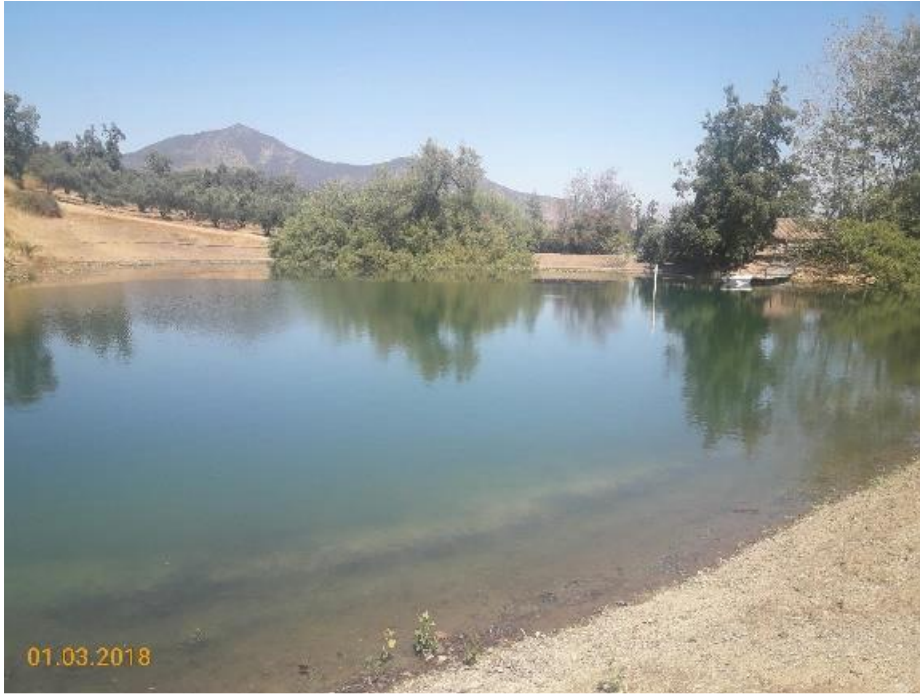
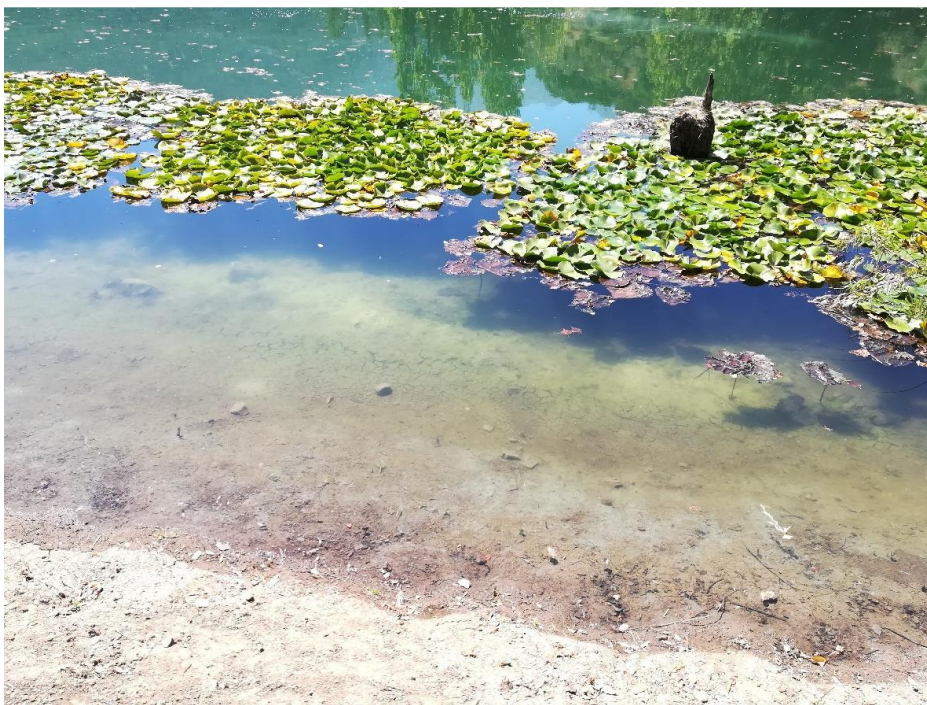
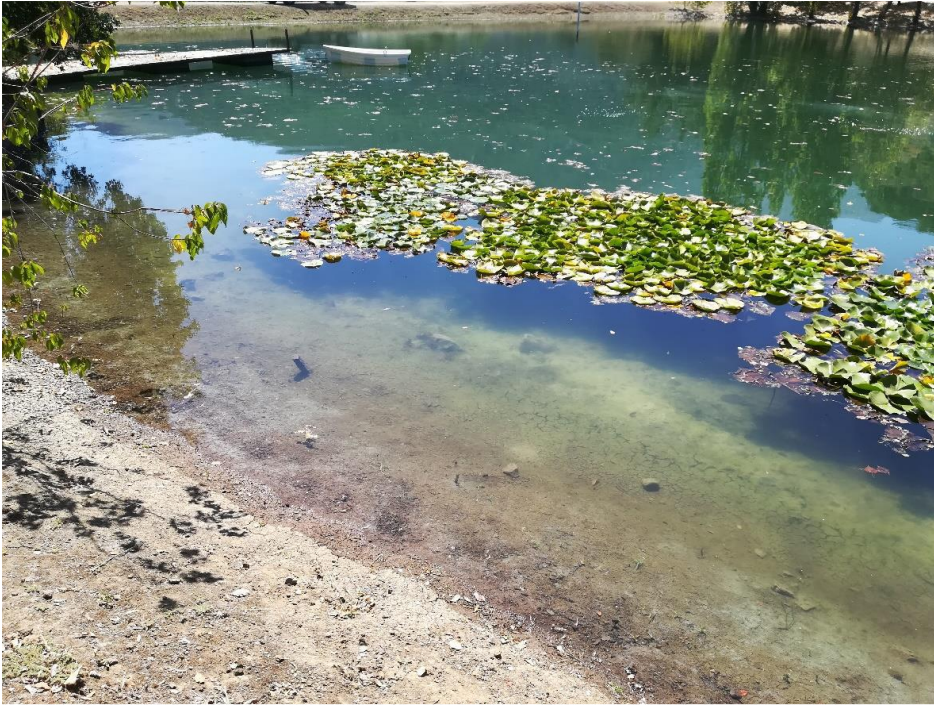
After 80 days of biological treatment, a brief filter clogging incident occurred due to internal residues being flushed from the pipes. However, this situation had been anticipated and did not cause major issues.

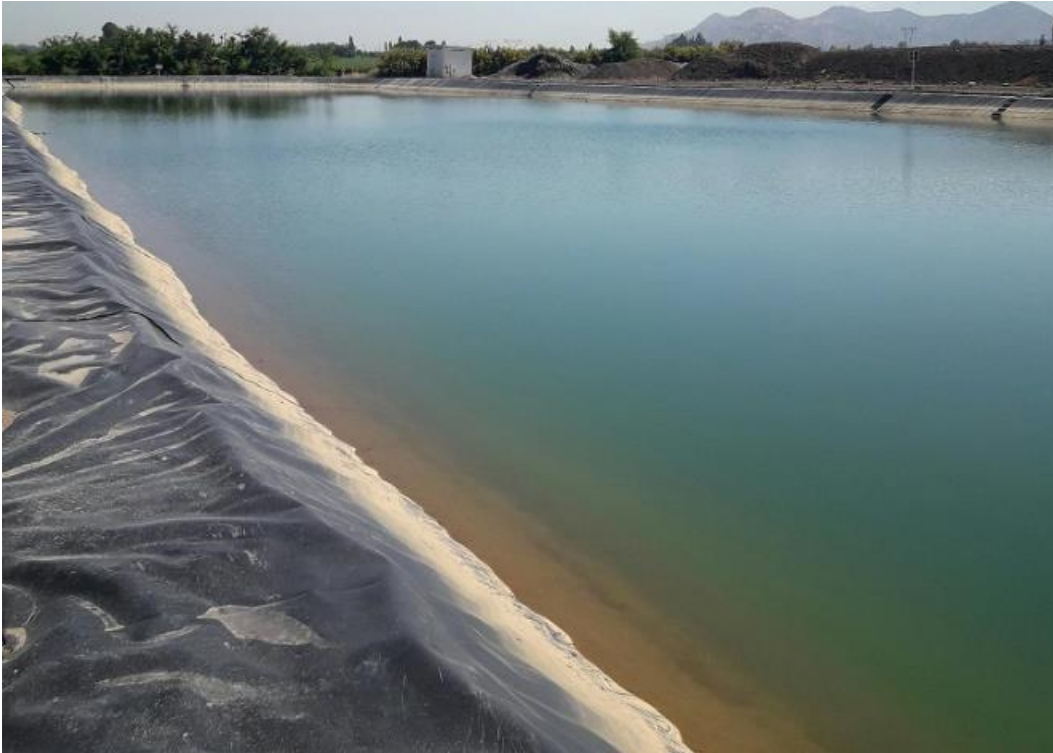
The pond remained free of algae throughout the treatment period, and a reduction in accumulated sediments along the pond's slopes was observed.

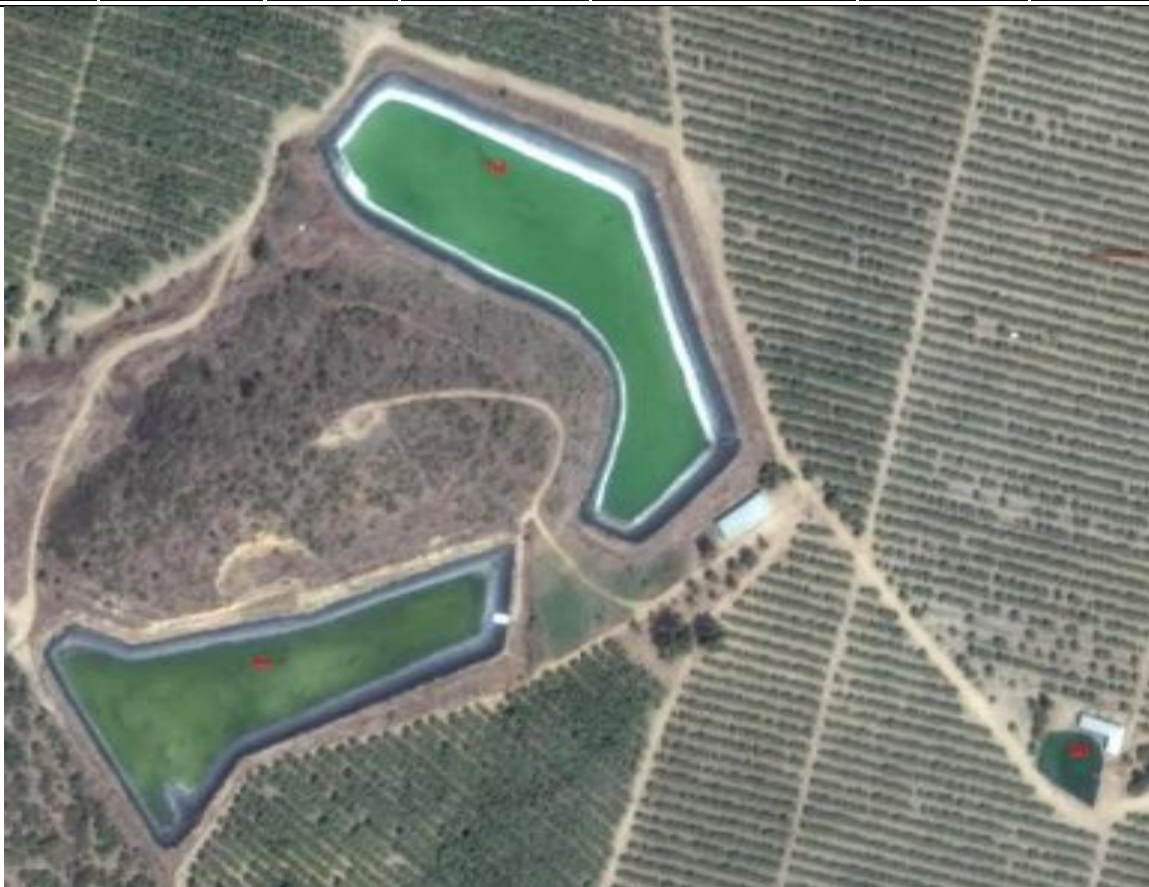
- Irrigated Area: 80 hectares
- Crops: Export table grapes
- Lining: Geomembrane

Pond	Surface Area (m <sup>2</sup> )	Volume (m <sup>3</sup> )	Water Source	Irrigated Volume (m <sup>3</sup> /month)	Retention (days)	Lining
Pond N°1	12,370	48,000	River	-	-	Geomembrane
Pond N°2	15,600	48,000	River	-	-	Geomembrane
Pond N°3	650	500	Ponds No. 1 & 2, Well	55,500	52	Geomembrane

Ponds N°1 and N°2, along with several wells, supply the Pond N°3. The long retention time in these ponds promotes algae growth, requiring treatment of the three ponds as a single unit.

Due to scheduling and decreased irrigation volume, the company decided to stop biological treatment in February, even though the summer season had not yet ended. Up until that point, no filter or dripper clogging issues had been observed, and the water remained clear and algae-free.

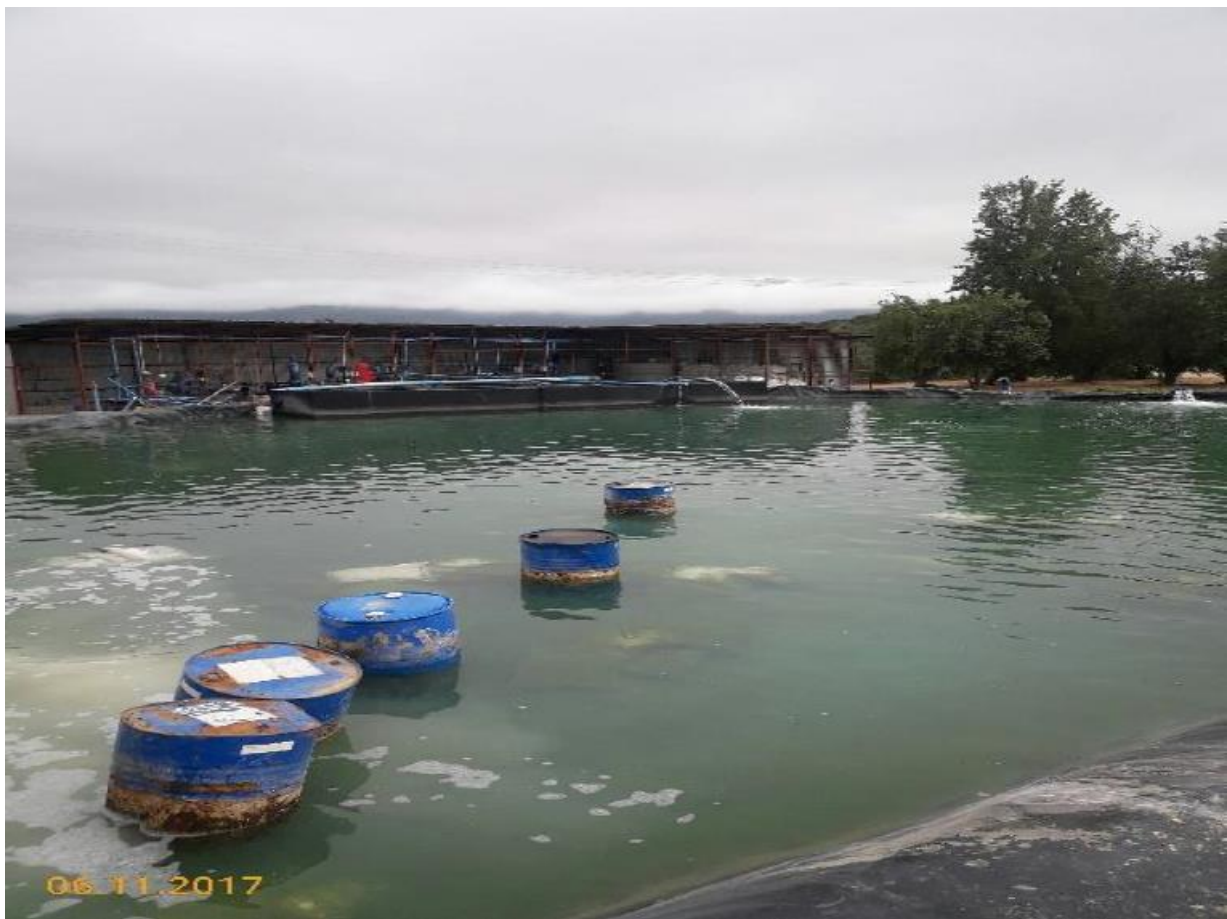
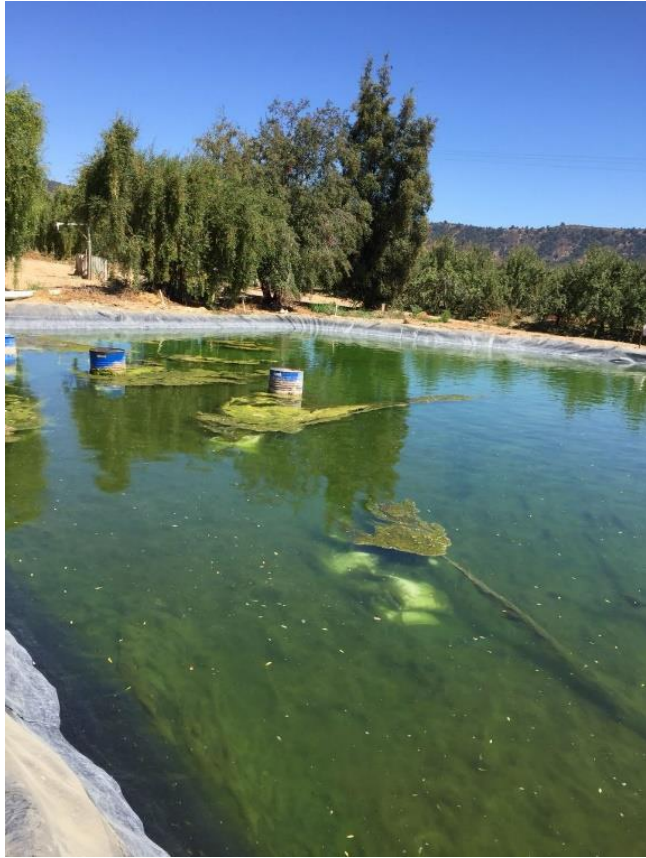
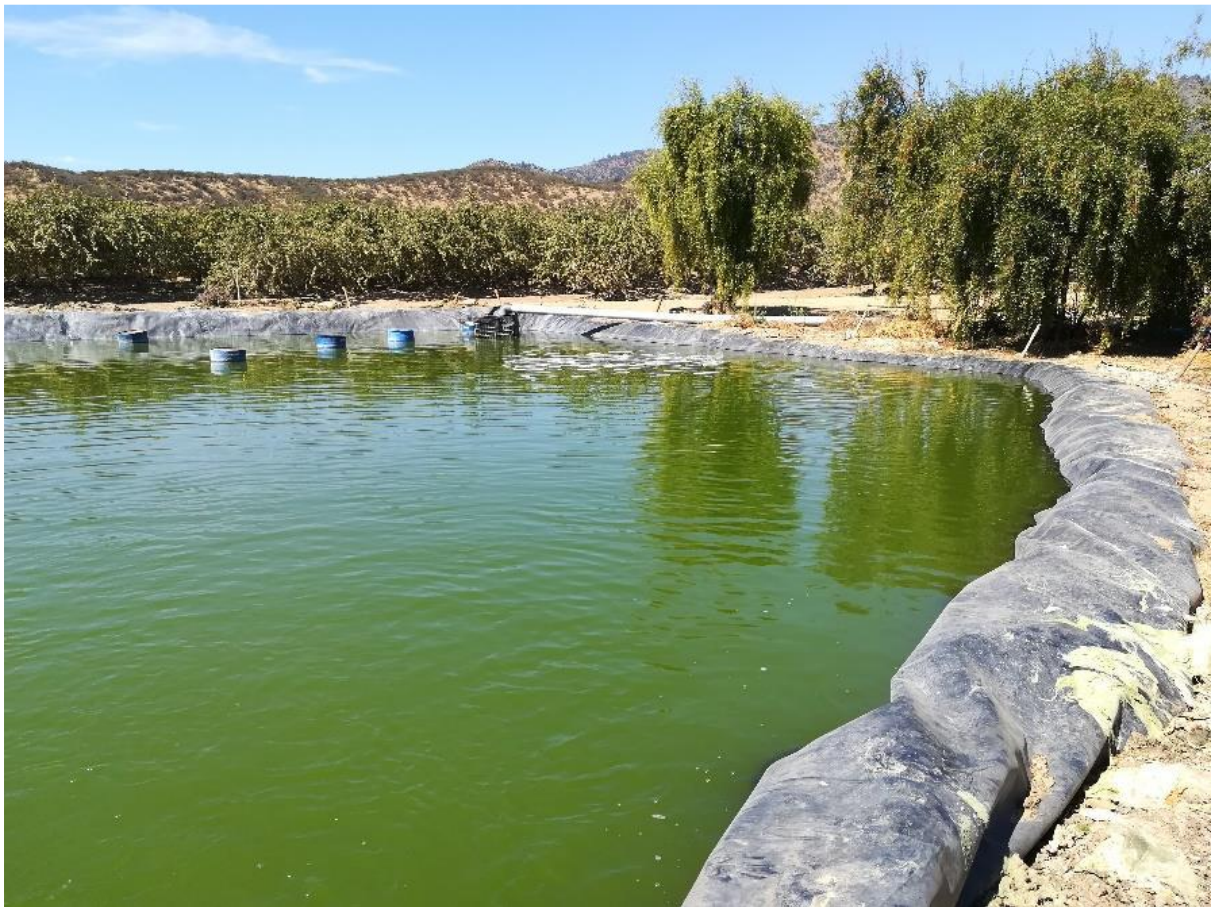
After biological treatment was stopped in February, no product was applied in March, leading to a sudden algae outbreak.

Given the rapid deterioration of the pond after stopping biological treatment, it was decided to resume treatment, remove floating algae, and apply a higher dosage than the regular treatment. A dose of 1.6 g/m<sup>3</sup> of irrigated water was used until the end of the irrigation season, effectively resolving the emergency.

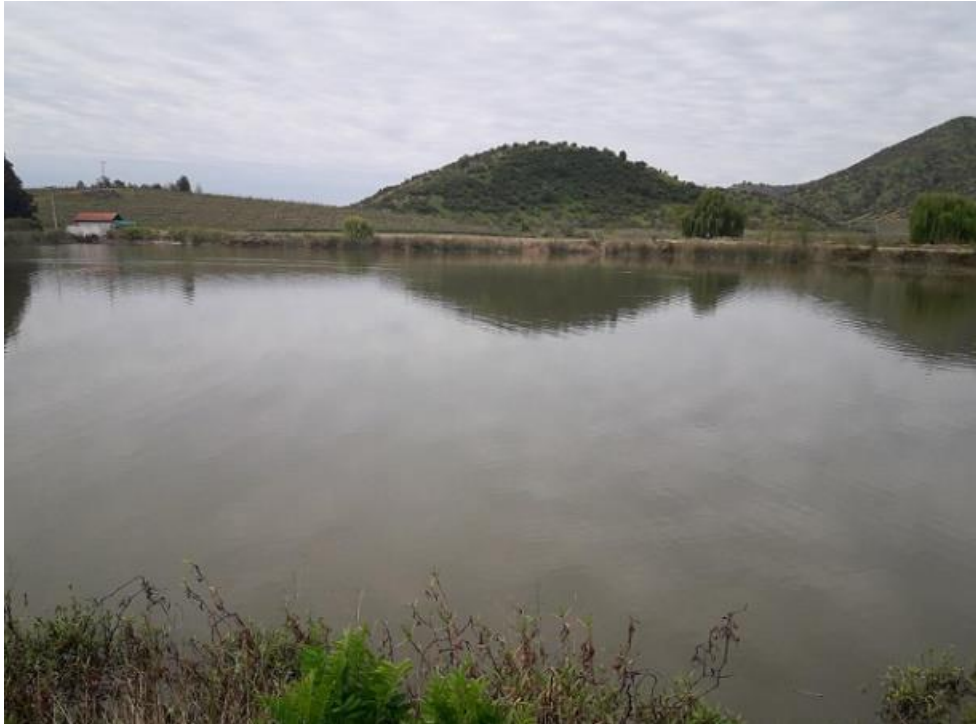
The clogging issue was completely resolved until the end of the irrigation season.
